Drainage District No. 238  
City of Kamrar  
414 Elm St.  
Kamrar, IA 50132

Re: Engineer's Report for Drain Tile Repairs

This report focuses on the existing 14-inch clay drain tile located in Section 35 of Independence Township, within the city limits of Kamrar, on the north side of the Union Pacific Railroad. The tile is in very poor condition, exhibiting several blowouts, large sinkholes, and extensive tree growth directly above it. It is likely that tree roots are obstructing the tile and have contributed significantly to the current failures.

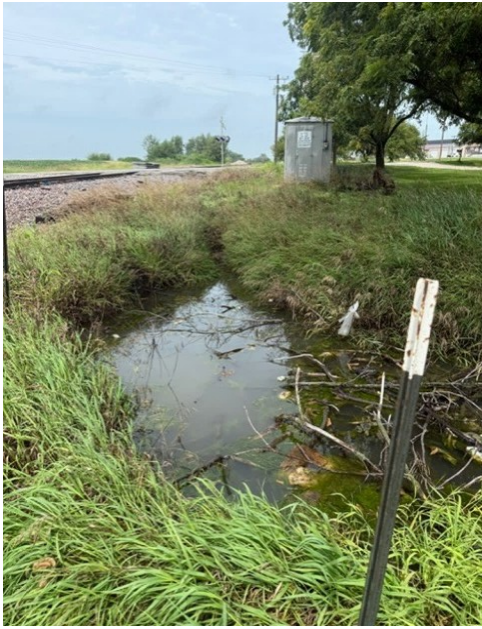
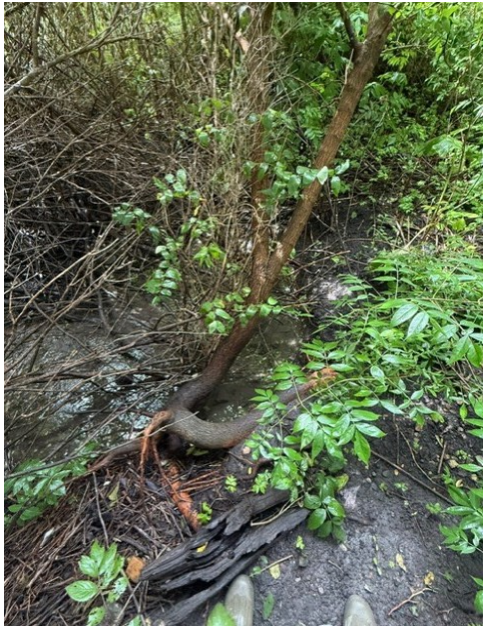
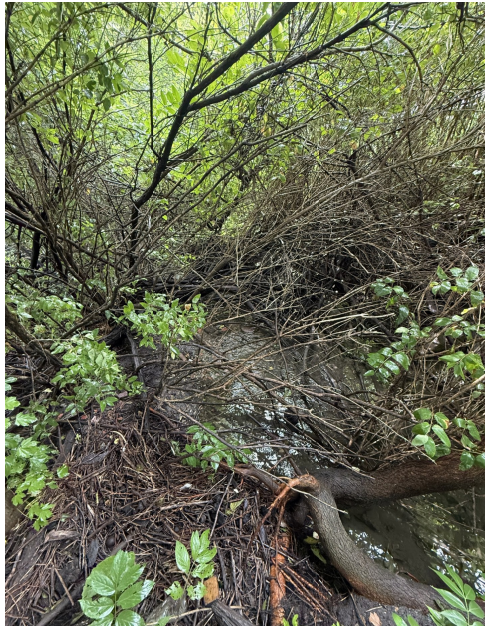
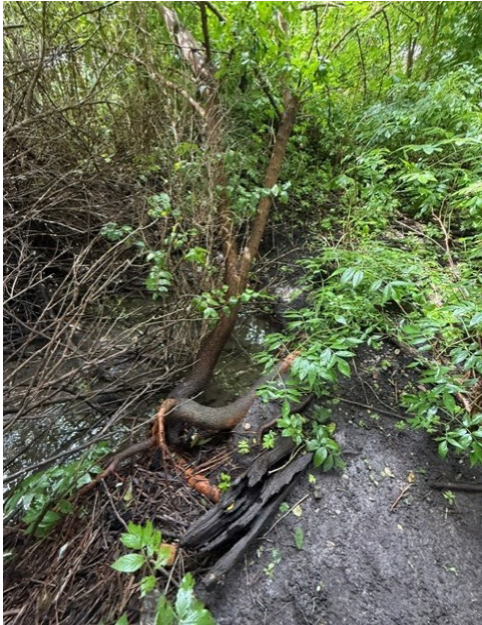
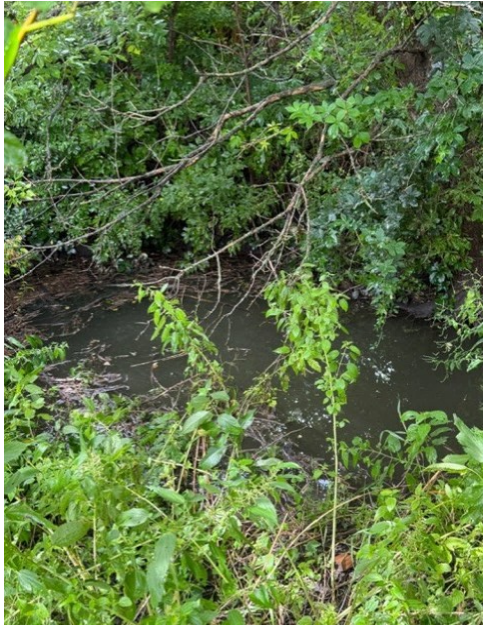
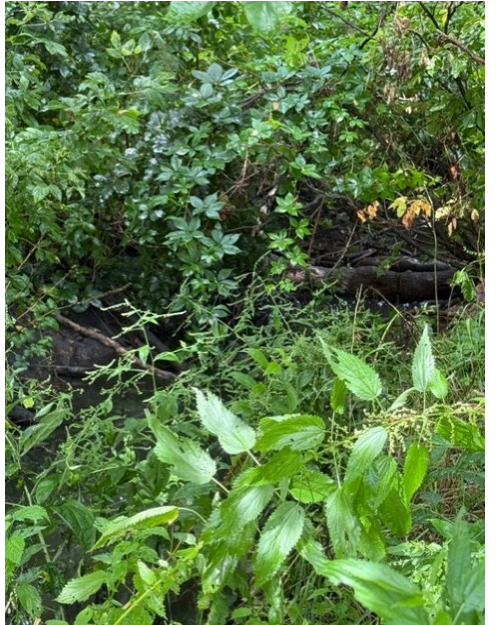
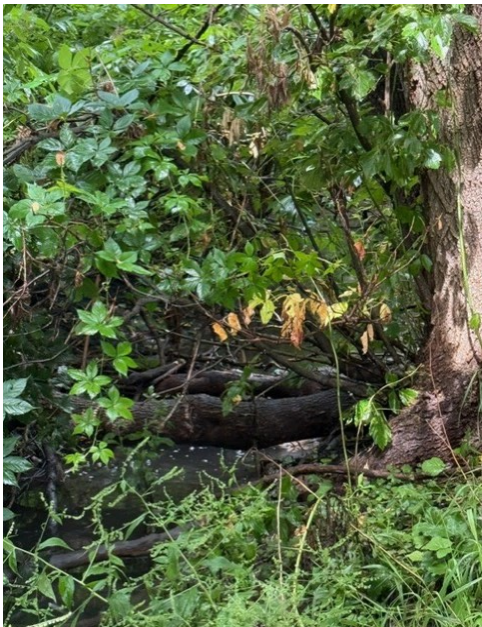
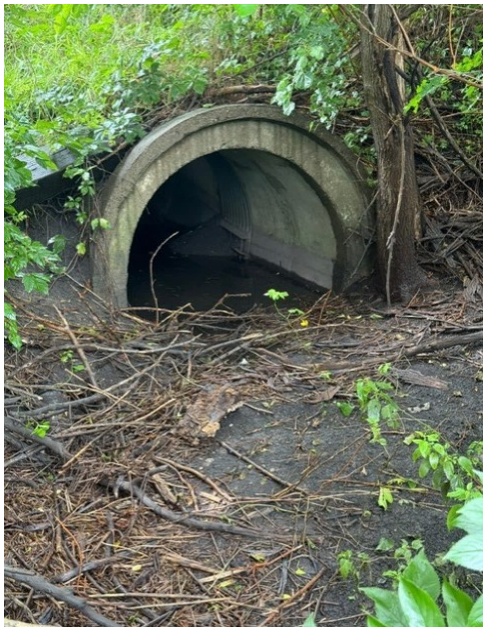
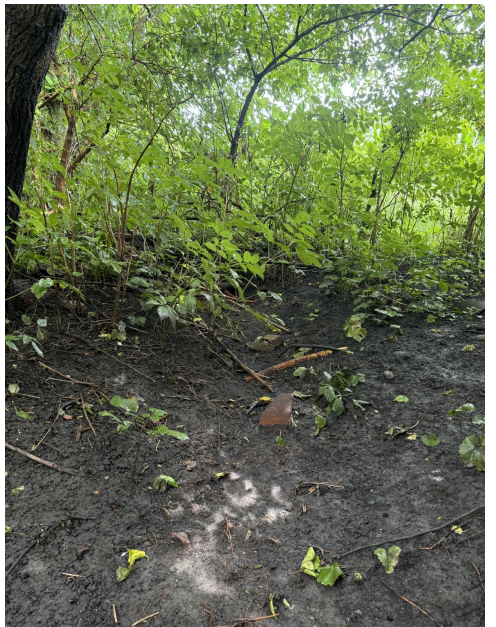
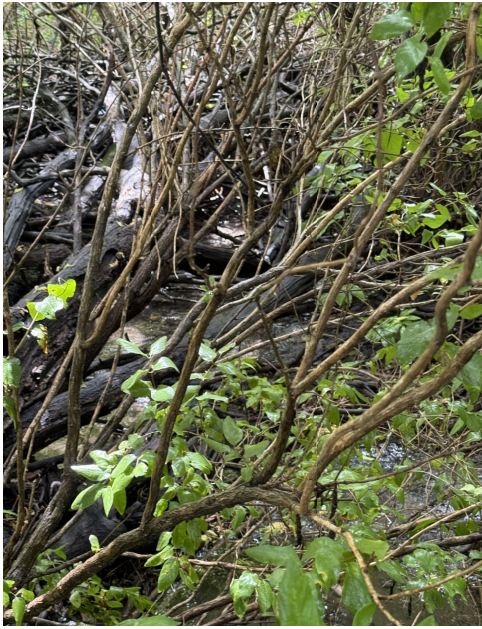
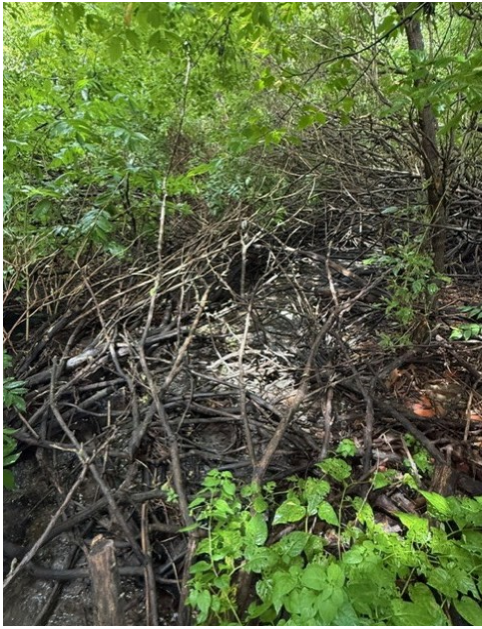
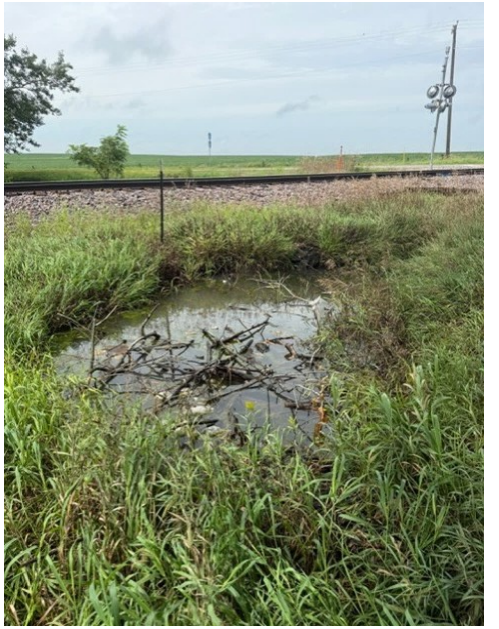
Enclosed with this report are photographs documenting the tile blowouts and excessive tree growth over the tile.

Due to the substantial tree growth within the Union Pacific Railroad right-of-way directly over the existing tile, it is neither feasible nor cost-effective to repair the tile in place. Rerouting the tile is the best long-term solution to avoid recurring maintenance issues.

We recommend rerouting approximately 600' tile using 15-inch HDPE pipe with taped joints, outside the impacted area. A plan sheet showing the proposed reroute is enclosed. We estimate the construction cost to be approximately \$40,000. Given the risk of continued silting and blockage, we recommend the work be completed as soon as possible, consistent with guidance in the *Iowa Drainage Guide*.
