Dallas County Drainage Ditches Reconnaissance Report

Dallas County, Iowa
2026

Drainage District No. 1

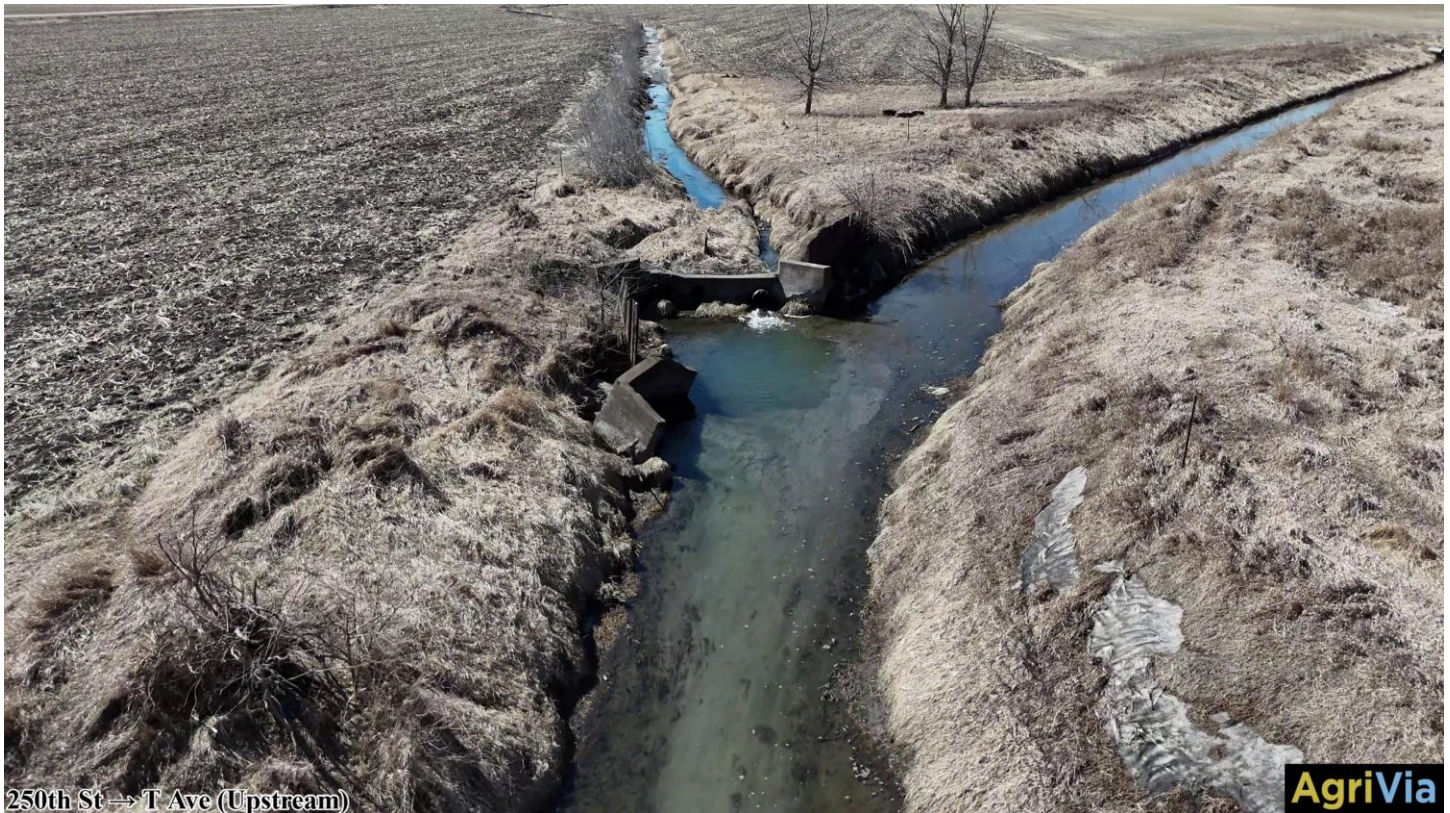
250th St → T Ave (Upstream)

The open ditch is approximately 2.6 miles long. Available records show the last major repair to this ditch was in 1983. The lower reach from the outlet to U Avenue shows sluggish flow and several submerged pipe outlets, even under the low flow conditions present at the time of survey. Several hundred feet of bank sloughing was observed, along with erosion gullies actively contributing sediment to the channel. Miscellaneous debris including broken pipe sections was noted. Vegetation is heavy in places, with large trees, small trees, and dense willows established along the banks.

Several bulkheads serving as outlets for major drainage district tiles can be seen. These are in very poor condition. Overall, the ditch appears to be in serviceable condition, although likely in need of a cleanout and repairs in the future.

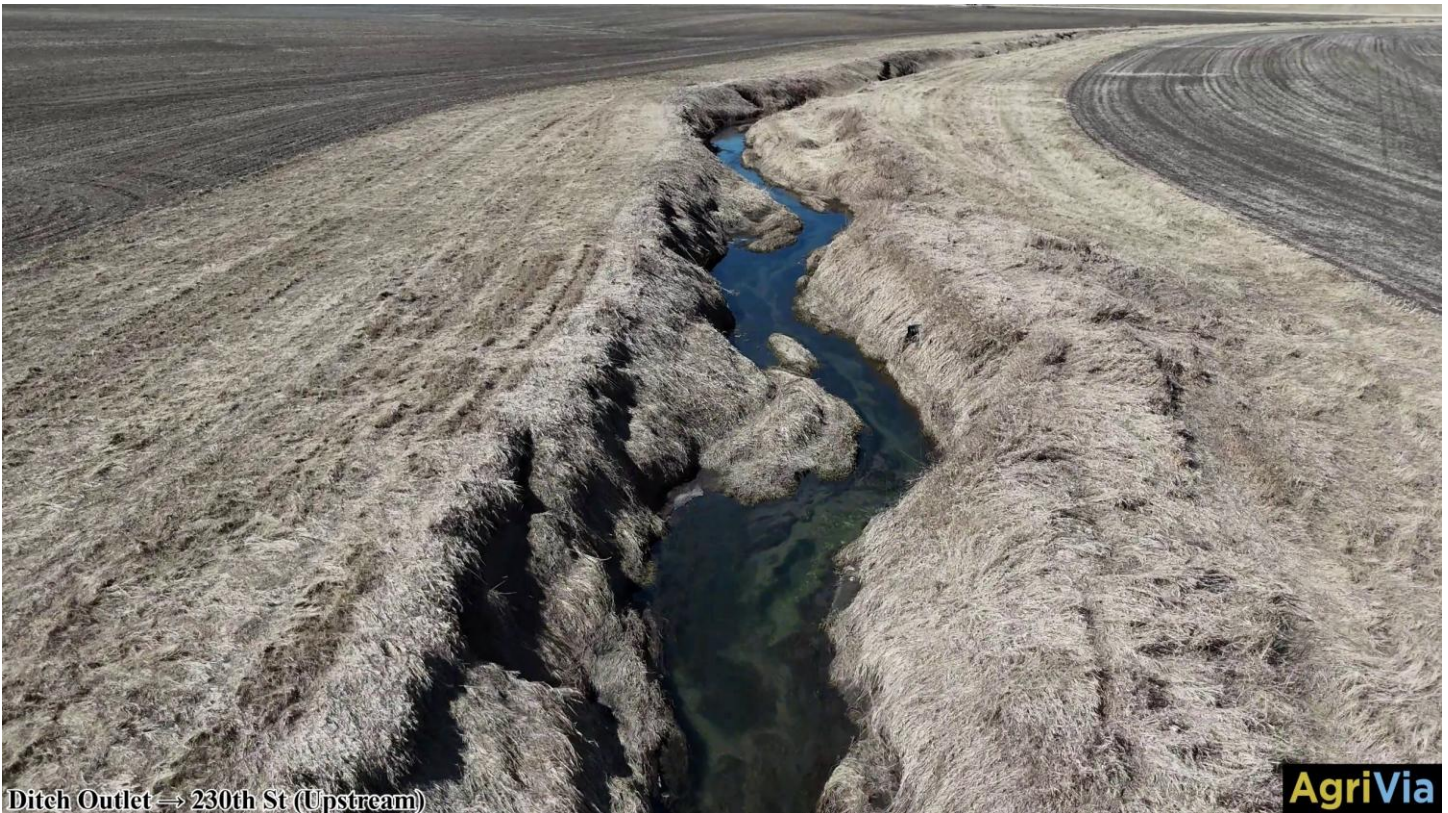
The open ditch is approximately 4.1 miles long. Available records show the last major repair to this ditch was in 1983. The lower reach shows extensive meandering, bank sloughing, erosion and silt deposition. Erosion gullies are actively contributing sediment to the channel. Miscellaneous debris including several beaver dams was present. In the upper reach, some tiles were submerged, even under the relatively low flow conditions in mid-March. Water movement was slow.

Woody vegetation is relatively light, although with some large trees, small trees, and dense willows established along the banks in limited places.

Beaver dams should be removed. Overall, the ditch is in poor condition and appears to need a cleanout.

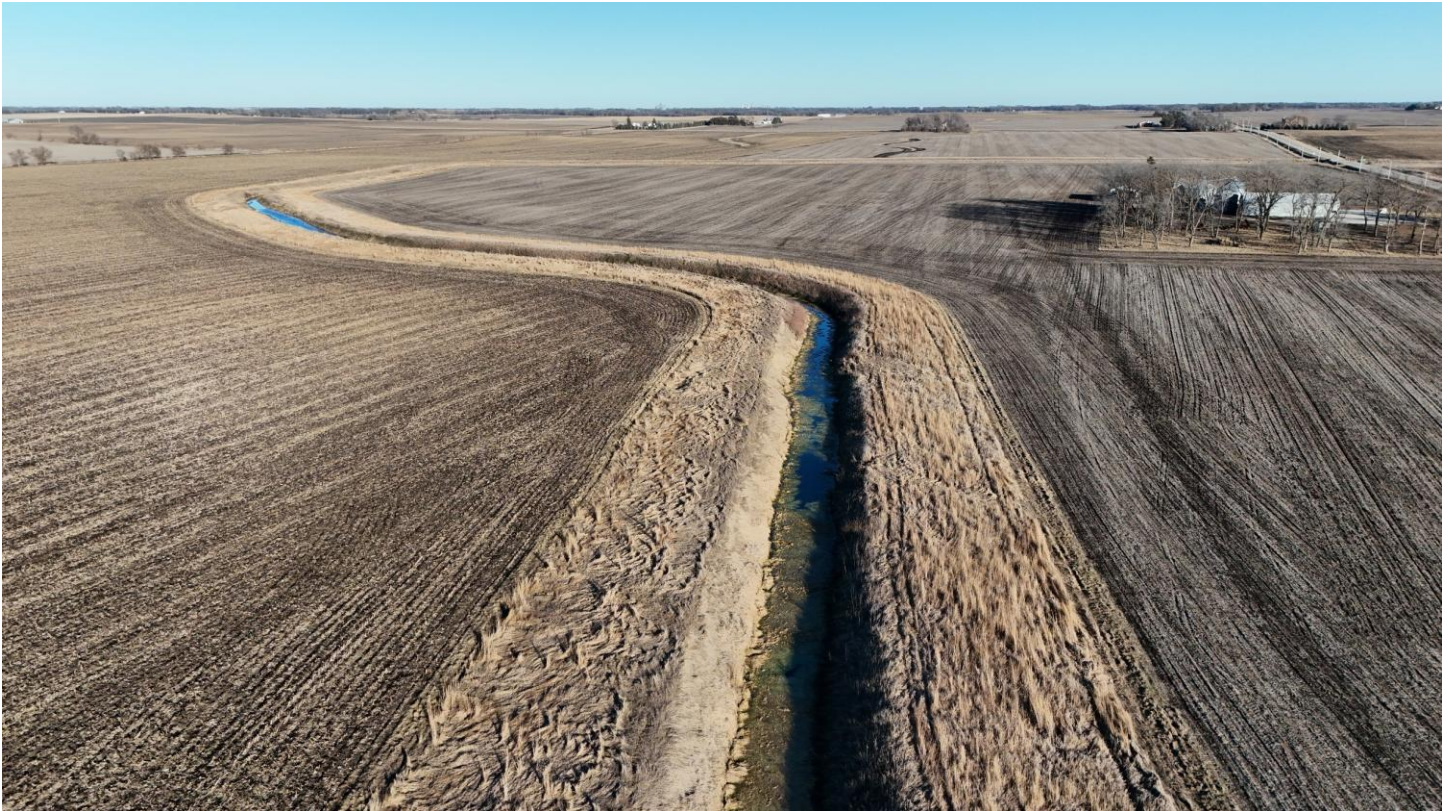
The open ditch is approximately 4.3 miles long. Available records show the last major repair to this ditch was in 2015. In the upper reach, many tiles were submerged, even under the relatively low flow conditions in mid-March. Water movement was extremely slow.

Woody vegetation is relatively light, although with some large trees, small trees, and dense willows established along the banks in limited places.

A petition for repairs has been filed, and AgriVia is preparing an improvement proposal to address the ditch's history of inadequate drainage and frequent repairs. Trees and woody vegetation will be removed as part of any project that proceeds.

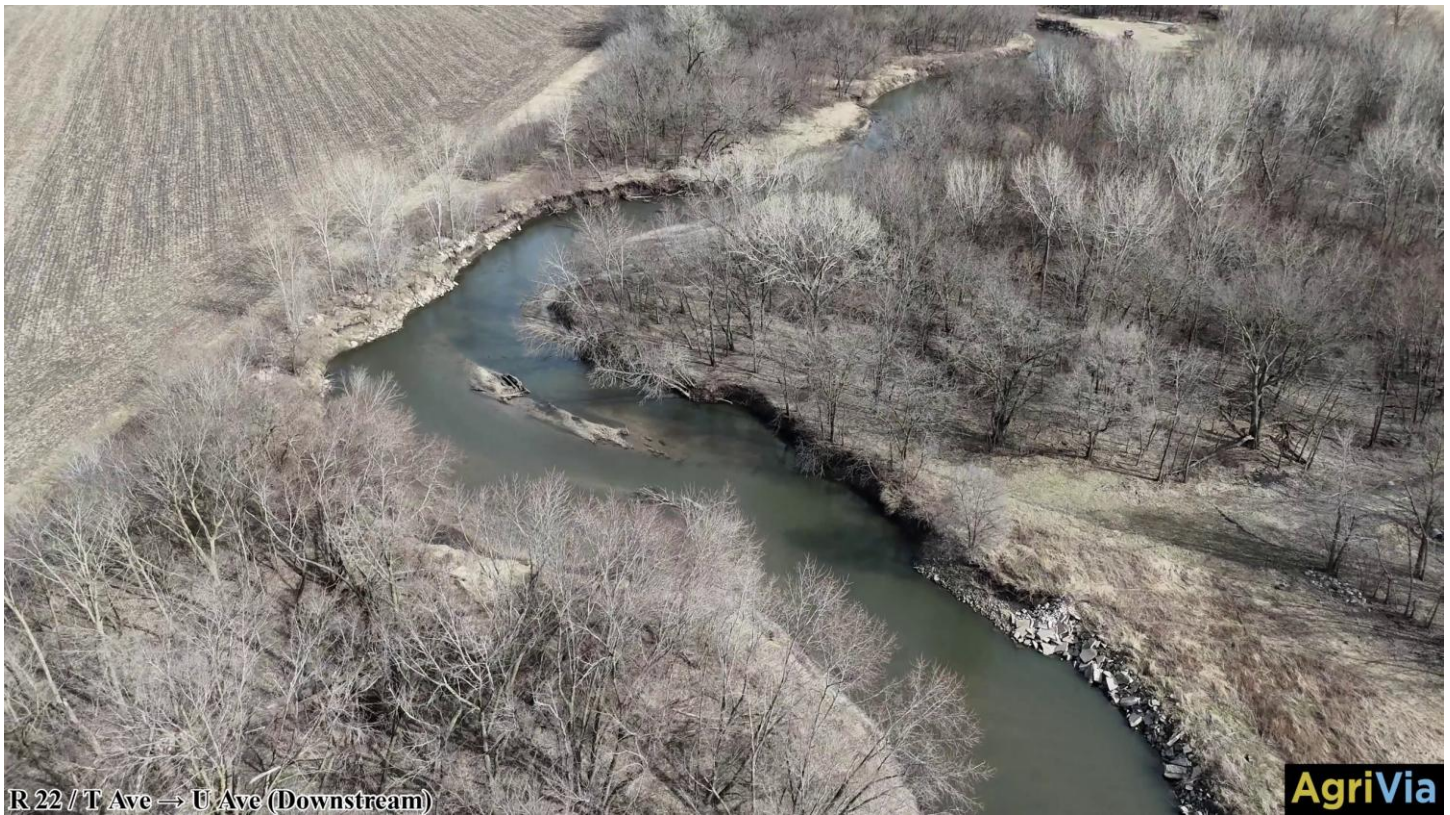
The open ditch is approximately 8.6 miles long. Available records show the last major work to this ditch was during its construction in 1910. This ditch is unique as it encompasses a stretch of the larger Beaver Creek system with tens of thousands of unassessed upstream acres draining to it.

Woody vegetation is extremely thick, with essentially the entire length of the ditch covered in a very large forest of trees. The ditch itself has completely broken out of its original channel in some places and cut large meanders into the surrounding lands.

This drainage district is effectively idle, but we recommend keeping it technically active in case work is desired in the future. It would be extremely difficult to reestablish a drainage district on a large stream such as this. Due to the conditions and history, we do not recommend any work on this ditch unless explicitly petitioned by landowners. The cost for any work here would likely far exceed any benefits received.

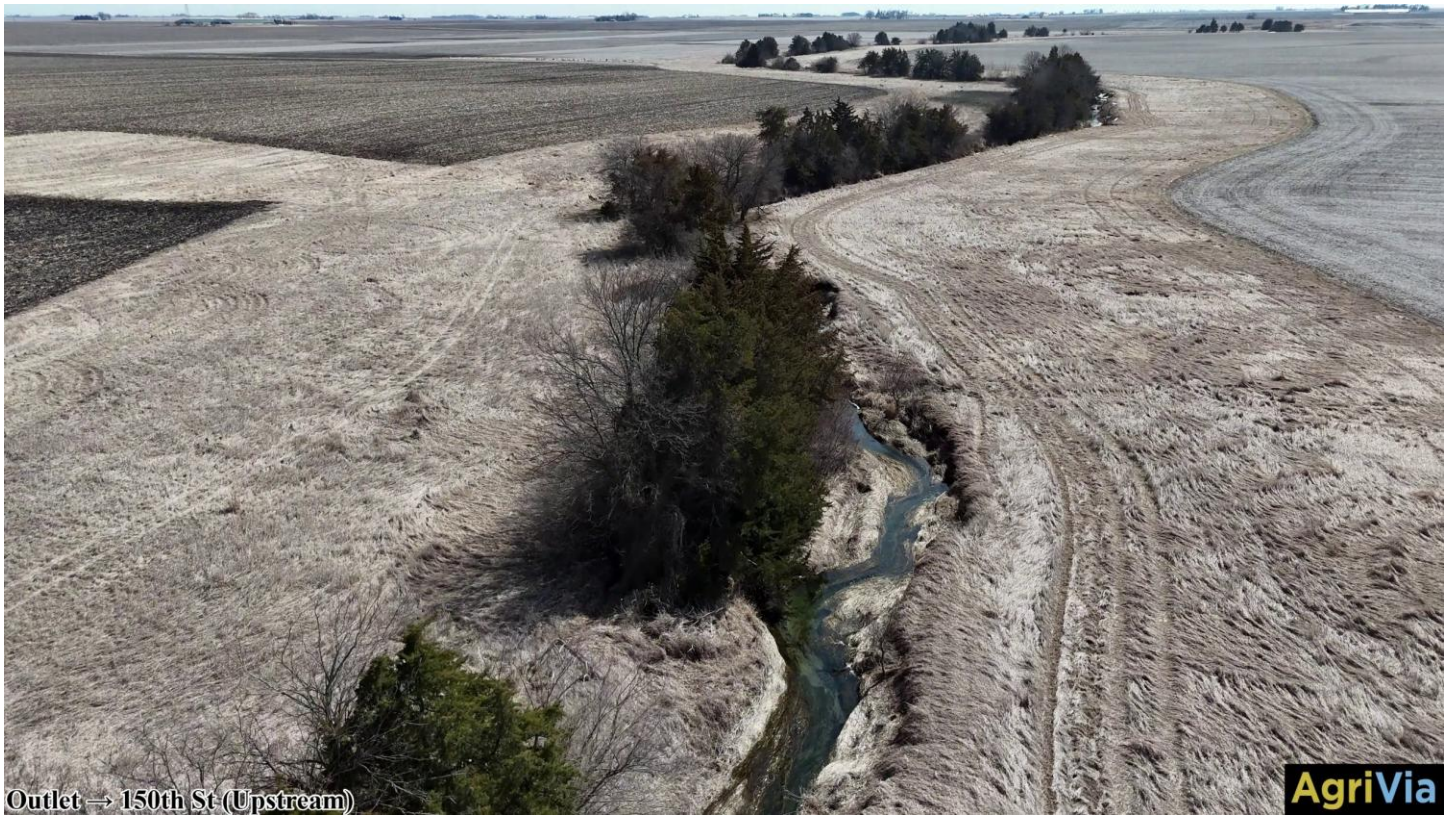
The open ditch is approximately 4.4 miles long. Available records show the last major repair to this ditch was in 1995. The lower reach shows extensive meandering, bank sloughing, erosion and silt deposition. Erosion gullies are actively contributing sediment to the channel. Large numbers of evergreen trees have grown up on the ditch banks in the 31 years since the 1995 cleanout. In the upper reach, some tiles were submerged, even under the relatively low flow conditions in mid-March. Water movement was slow with extensive aquatic grass growth.

Woody vegetation is heavy, with large trees, small trees, and dense willows established along the banks in large stretches.

This ditch should have all trees and beaver dams removed from within the banks. Overall, the ditch is in poor condition and appears to need a cleanout.

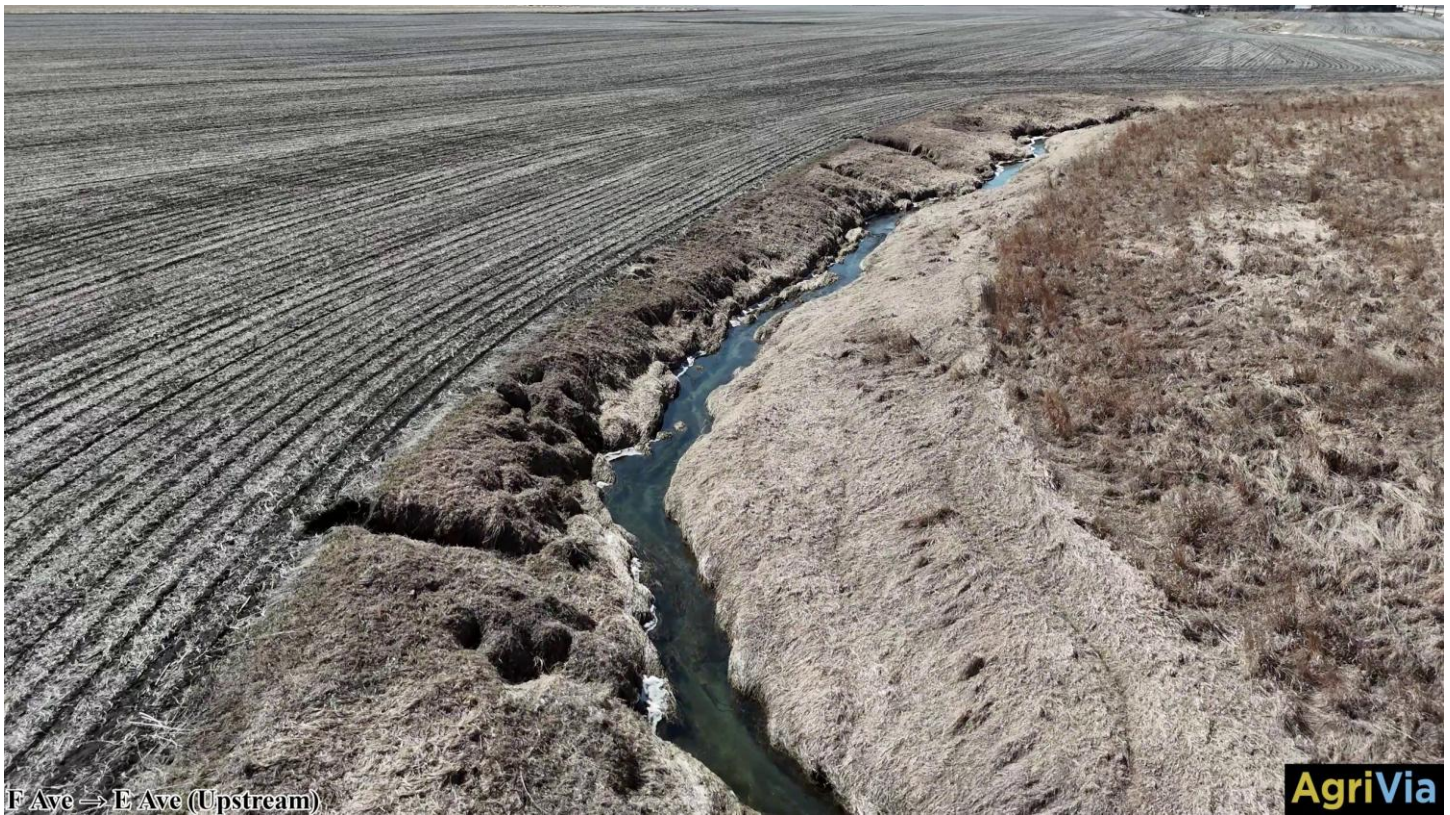
The open ditch is approximately 2.2 miles long. Available records show the last major earthwork on this ditch was its construction in 1911. There was a tree and debris clearing project in 2006. The lower reach shows major meandering, bank sloughing, erosion and silt deposition. Numerous erosion gullies are actively contributing sediment to the channel. A significant stretch of the ditch has been used in the past for pasture, which causes damage to the structure of the ditch. In the upper reach, water movement was slow with extensive aquatic grass growth.

Woody vegetation is moderate, with small trees and brush established along the pasture section. A significant stretch of large trees has grown up along the north bank where the ditch parallels Highway 141. Some of these may be too close to the ditch and may need to be removed for maintenance access.

Overall, the ditch is in very poor condition and appears to need a cleanout.

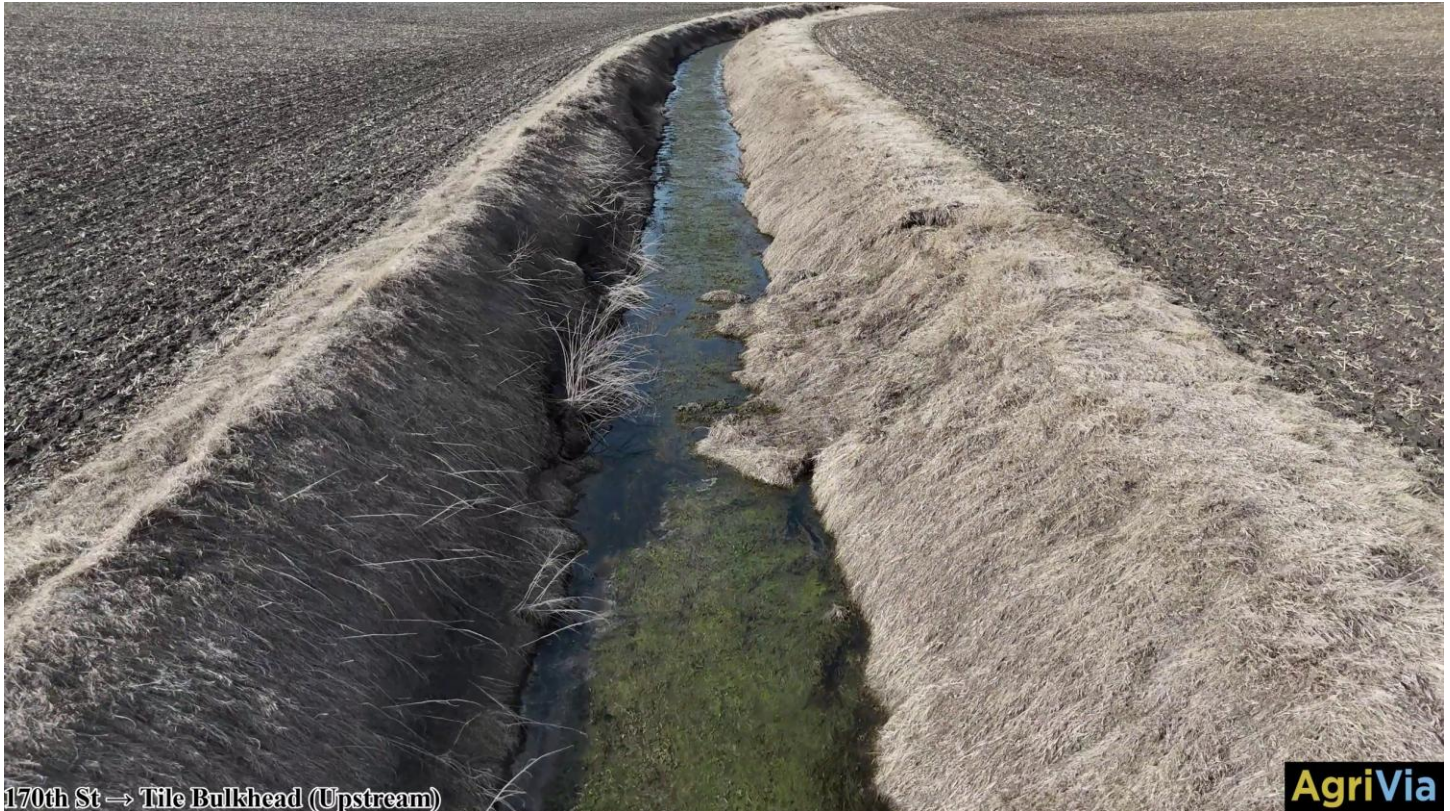
The open ditch is approximately 2.9 miles long. Available records show the last major earthwork to this ditch was its construction in 1912. There was a tree and debris clearing project in 2001. The lower reach shows major meandering, bank sloughing, erosion and silt deposition. In the middle and upper reaches, some tiles were submerged, even under the relatively low flow conditions in mid-March. There were also periodic bank slides causing siltation and pinching off water flow. Water movement was very slow with extensive aquatic grass growth.

Woody vegetation is very light, with only a few small trees and brush.

Overall, the ditch is in poor condition and appears to need a cleanout.

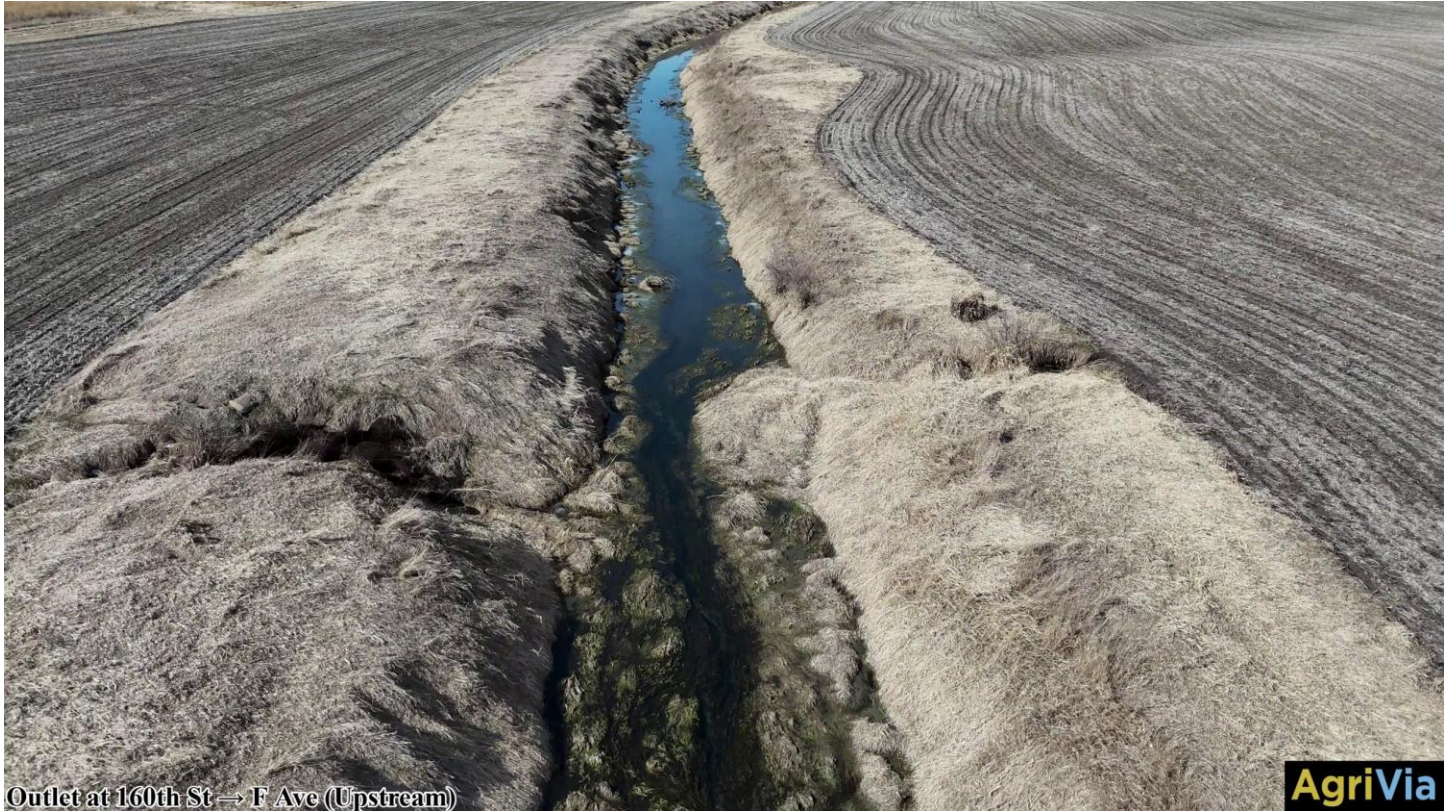
Outlet at 160th St → F Ave (Upstream)

The open ditch is approximately 0.6 miles long. Available records show the last major earthwork to this ditch was a cleanout in the late 1990s. Water movement was very slow with extensive aquatic grass growth. Woody vegetation is very light, with only a few small trees and brush. Several rusted or broken tile outlets can be seen. The banks appear to be unstable, with numerous sloughs, and the present width of the ditch indicates historical problems with slope stability. Several large gullies can be seen which are cutting into the banks and depositing silt into the ditch. Erosion protection should be installed at these locations.

Overall, the ditch is in decent condition and appears to be functioning adequately, although in serious need of erosion protection on the surface gullies.

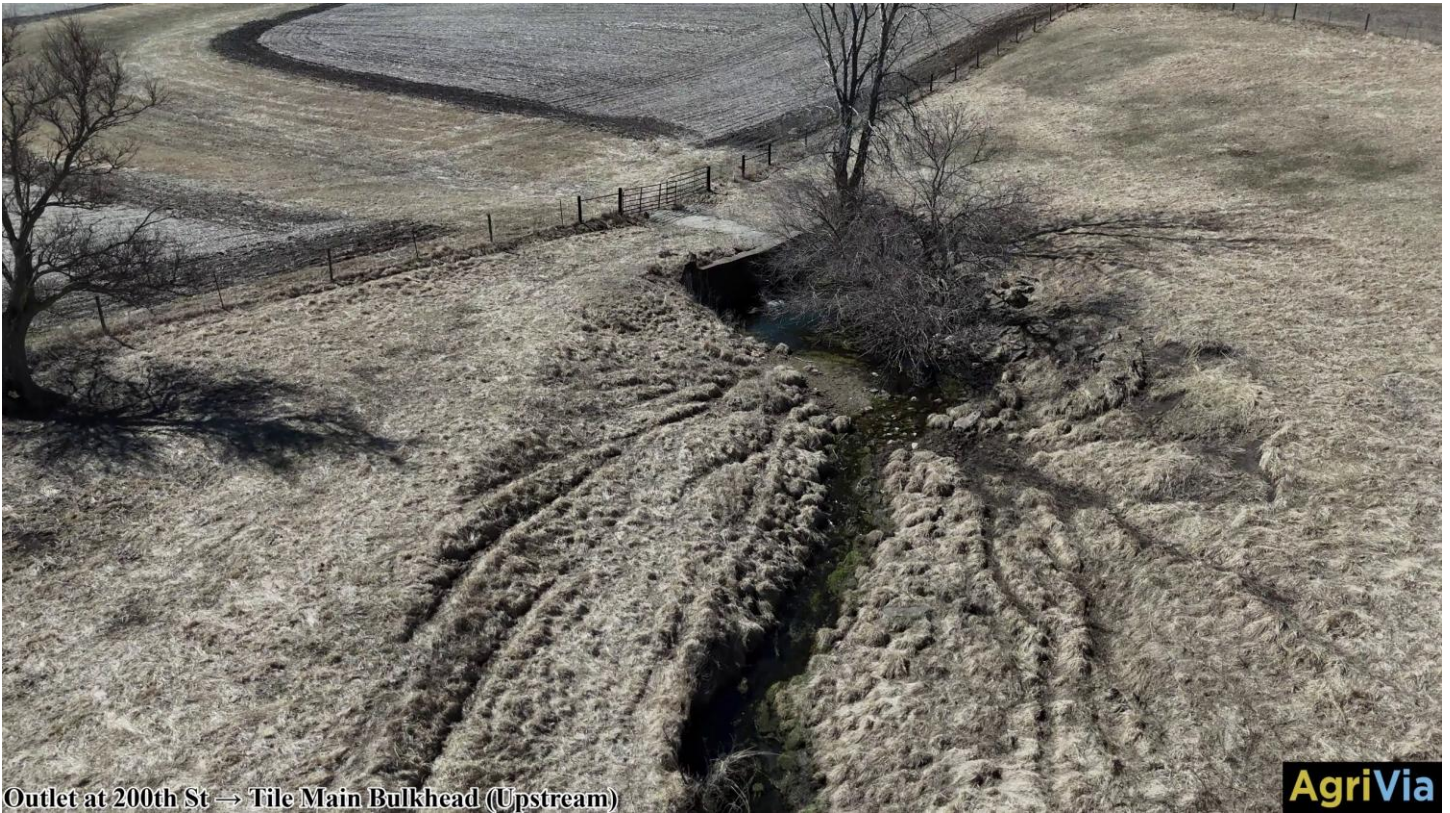
Outlet at 200th St → Tile Main Bulkhead (Upstream)

The open ditch is approximately 0.3 miles long. Available records show the last major earthwork to this ditch was its original construction in 1918. Water movement was very good; it appears the ditch has significant fall over its short distance. There were a few medium size trees downstream of the bulkhead. Due to the high fall, the ditch is unlikely to need maintenance in the future, so these can be left. The trees growing around the tile bulkhead should be removed, however.

Overall, the ditch is in good condition, with only the trees near the bulkhead needing to be removed.

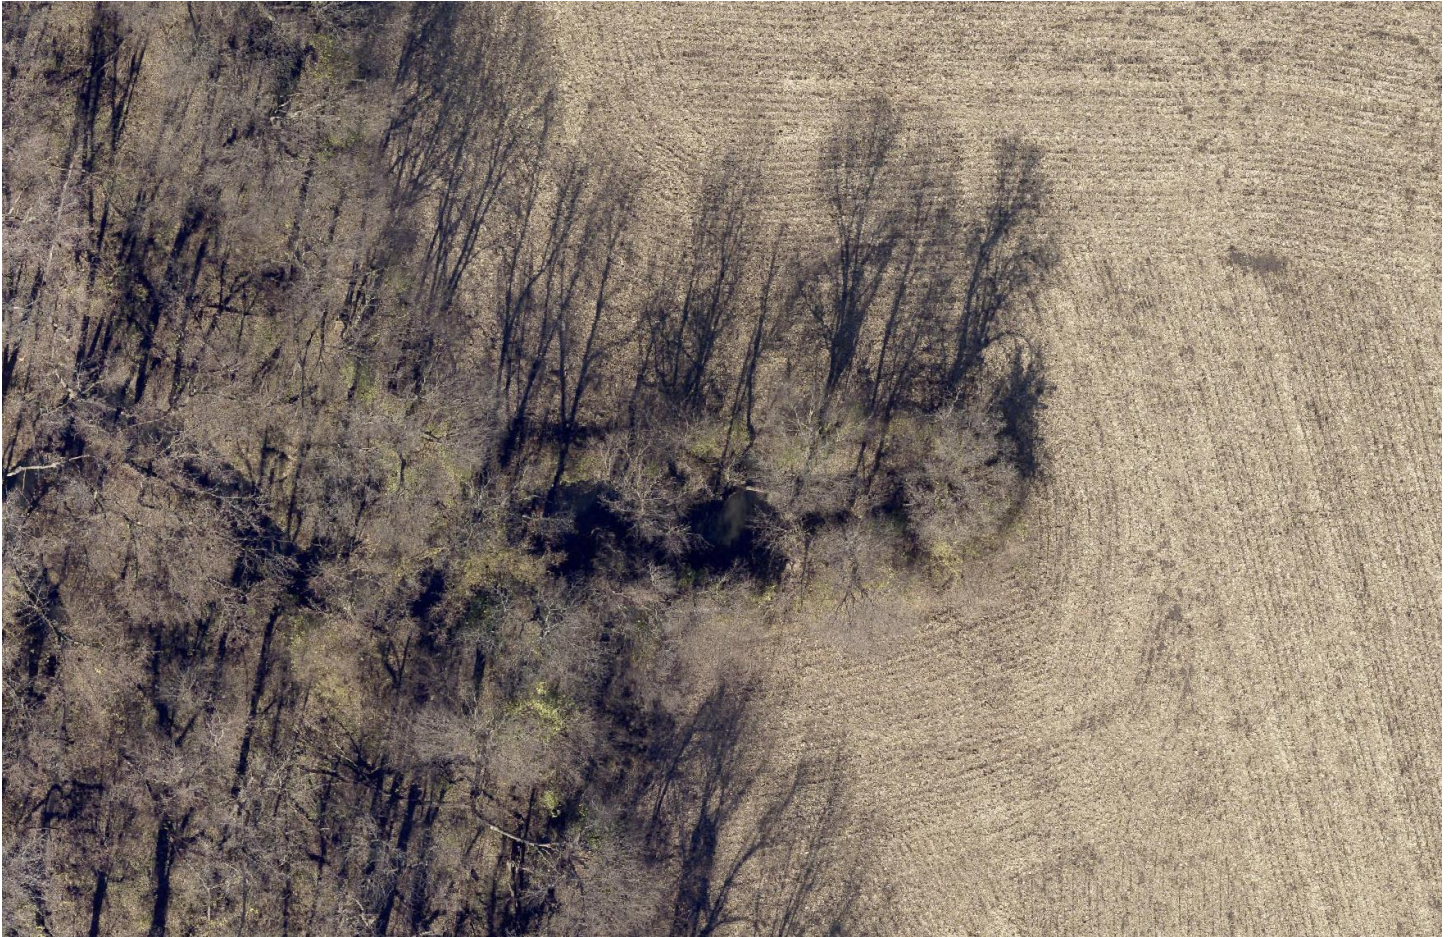
The open ditch is approximately 0.1 miles long. Available records show the last major earthwork to this ditch was its original construction in 1920. There are many large trees downstream of the bulkhead. This ditch is unlikely to need maintenance in the future, so these can be left. The trees growing around the tile bulkhead should be removed, however.

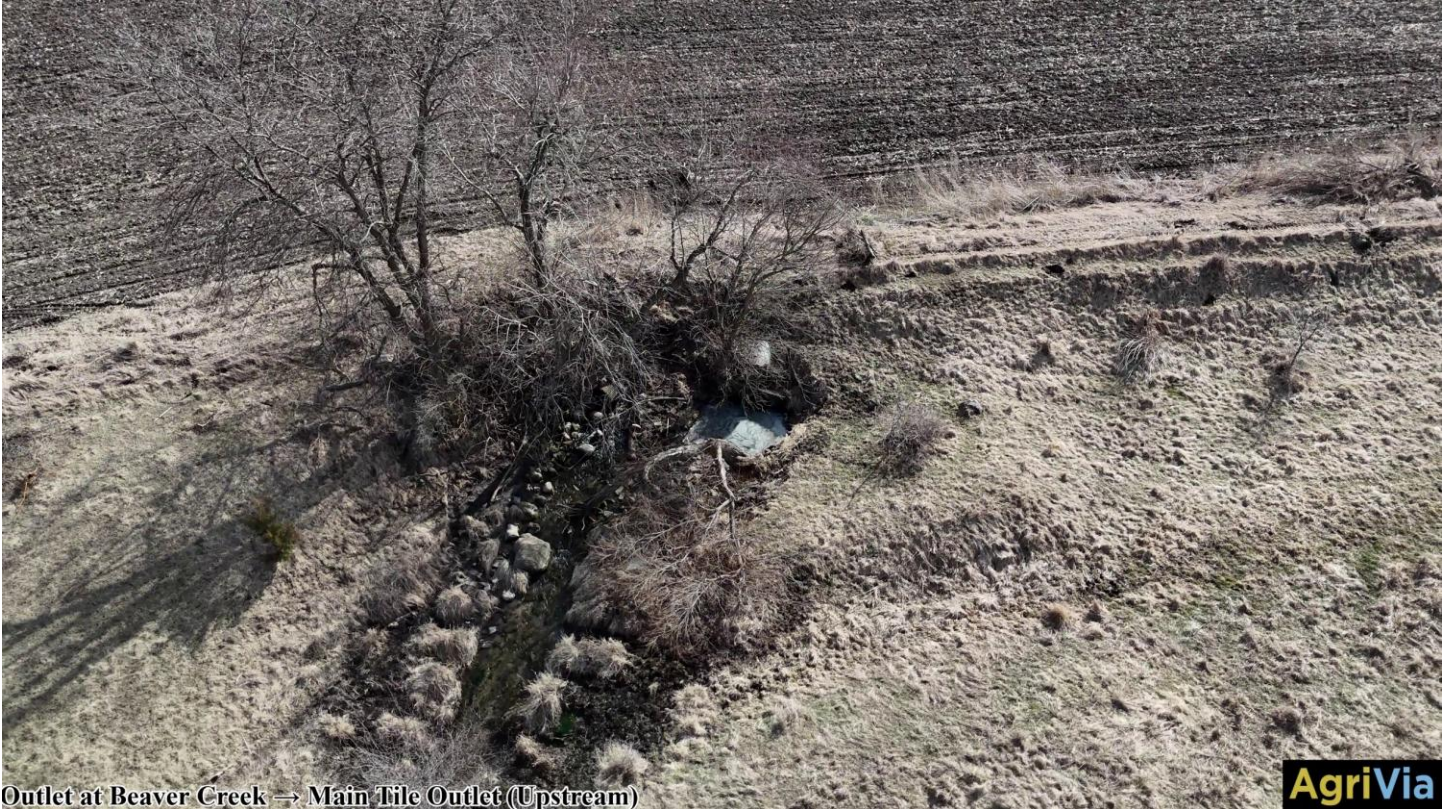
Outlet at Beaver Creek → Main Tile Outlet (Upstream)

The open ditch is approximately 0.1 miles long. Available records show the last major earthwork to this ditch was its original construction in 1949. Water movement was very good; it appears the ditch has significant fall over its short distance to Beaver Creek. There were several medium size trees downstream of the bulkhead. Barring a tile improvement project and considering the present condition of the ditch, maintenance is unlikely in the future, so these can be left for the time being. The trees growing around the tile bulkhead should be removed, however.

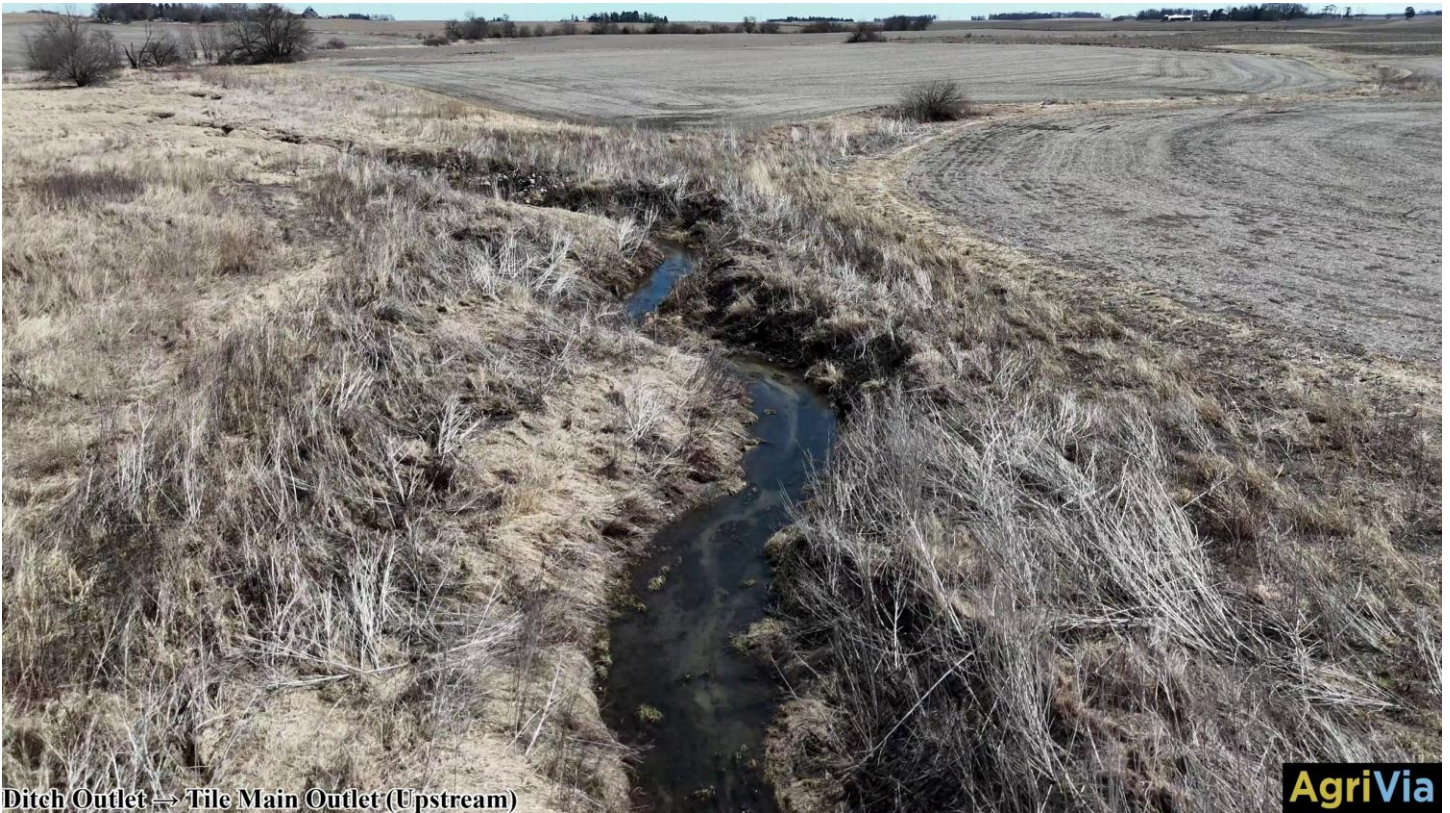
Ditch Outlet → Tile Main Outlet (Upstream)

The open ditch is approximately 0.25 miles long. This is a new ditch, constructed in 2024 as part of an improvement project. Water movement was very good; the ditch has significant fall over its short distance. There are no trees growing on this ditch. This ditch should be on rotation to have trees sprayed and cut every three years.
